# PENGURUSAN TENAGA ELEKTRIK

## ROOM DATA SURVEY

The survey covered 26 rooms located within the FTKIP building. Measurements were conducted to evaluate indoor environmental quality and energy consumption characteristics. Parameters measured included illuminance (lux), temperature, relative humidity (RH), and carbon dioxide (CO<sub>2</sub>) concentration. The survey also assessed electrical loads and lighting systems to identify opportunities for energy savings.

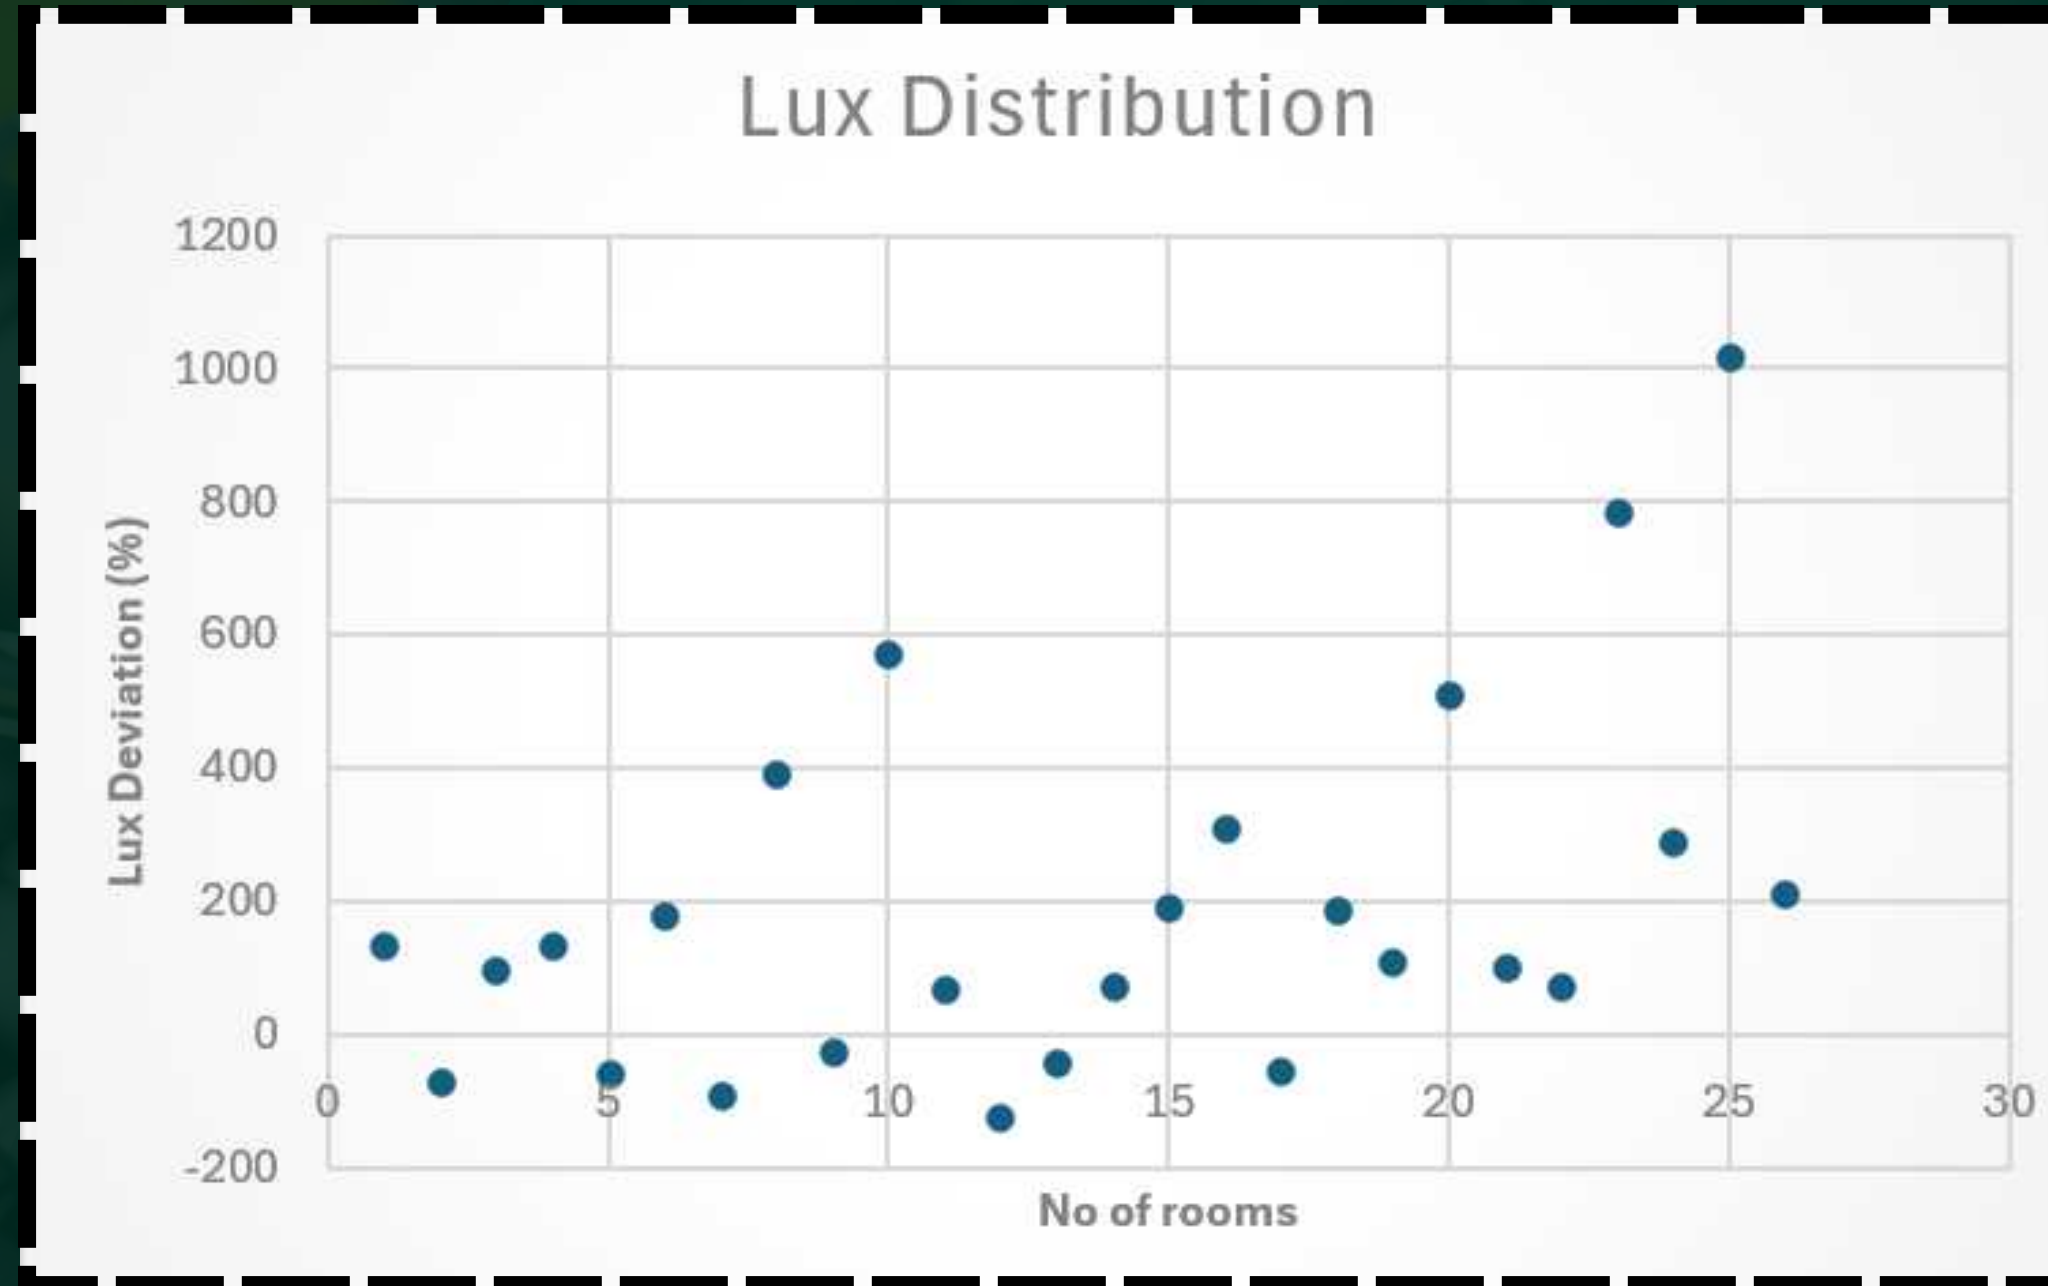
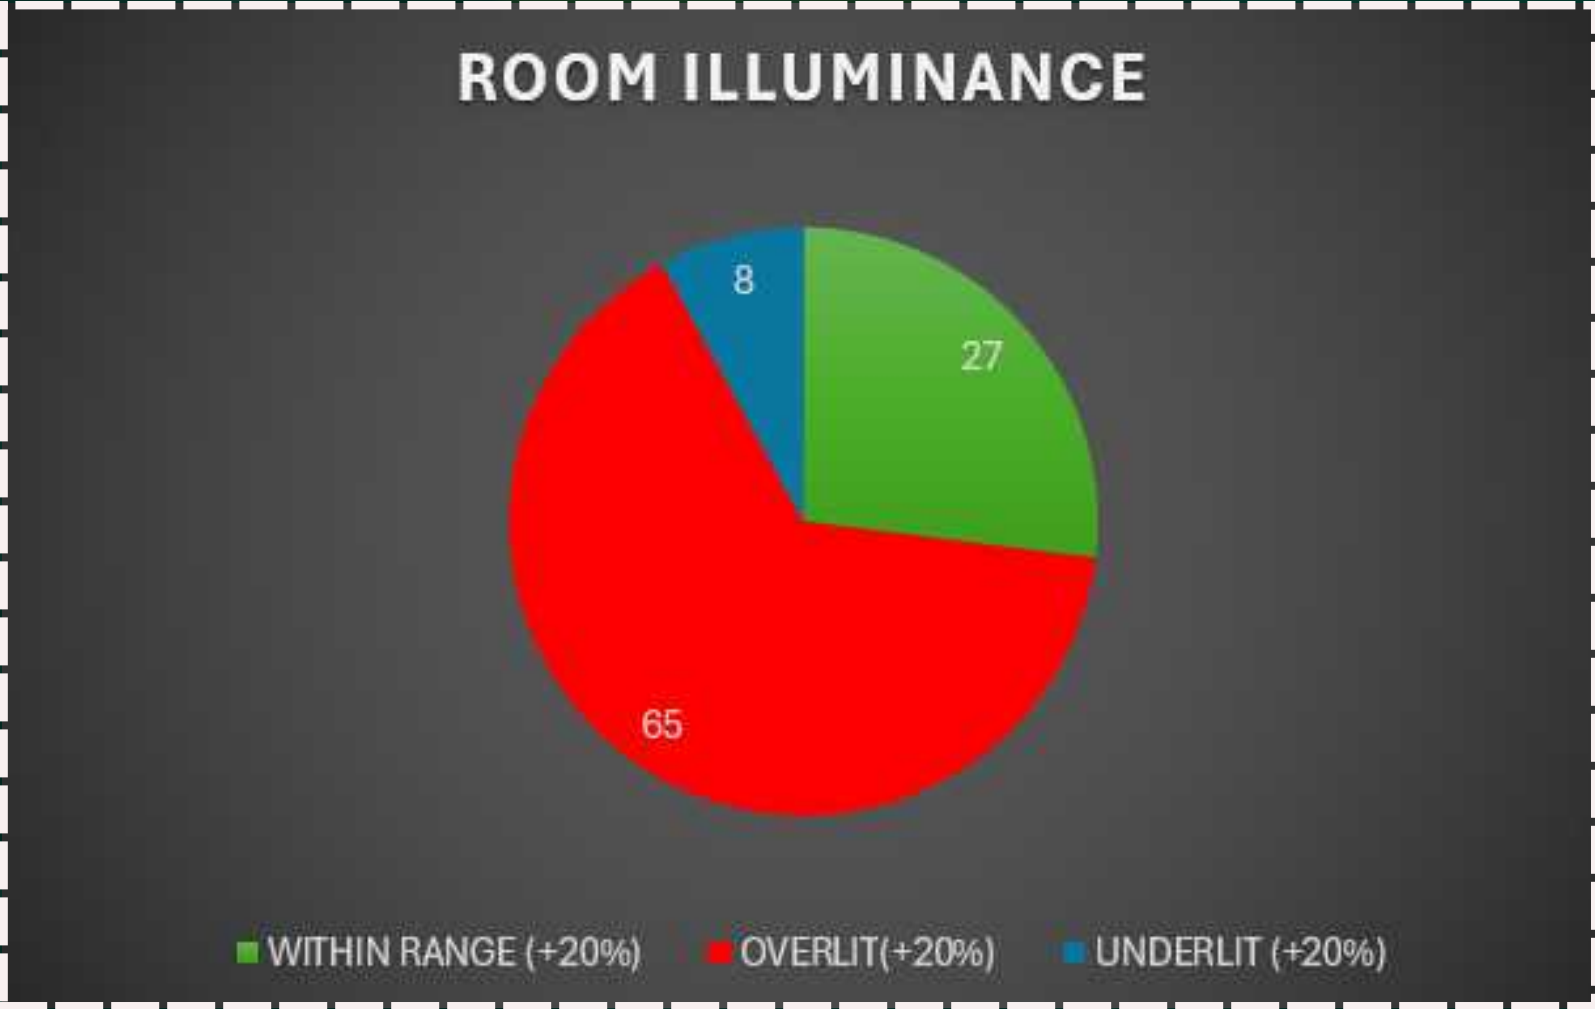
Based on the results, only 7 rooms, which is 27%, were within the acceptable illumination range. Meanwhile, 17 rooms, or 65%, were found to be overlit. This shows that most rooms had lighting levels higher than the recommended standard. Only 2 rooms, or 8%, were underlit, indicating insufficient lighting.

- 7 rooms within range
- 17 rooms overlit
- 2 rooms underlit
- Most rooms exceeded the recommended MS 1525 lux level.

- Lighting energy can be reduced by switching off unused lights, using suitable lamp wattage, and maximizing natural daylight. Overlit rooms should be reviewed to reduce unnecessary lighting without affecting visibility.
- Air-conditioning systems should be maintained regularly to improve cooling performance. Thermostat settings should be adjusted to a suitable comfort range, and doors or windows should be kept closed when air-conditioning is operating.
- Rooms with high humidity should improve ventilation and air circulation. Regular maintenance of air-conditioning filters and drainage systems can also help reduce humidity levels.
- Energy awareness should also be promoted among staff and students. Simple practices such as turning off lights, fans, air-conditioners, and unused electrical equipment can help reduce overall energy consumption.

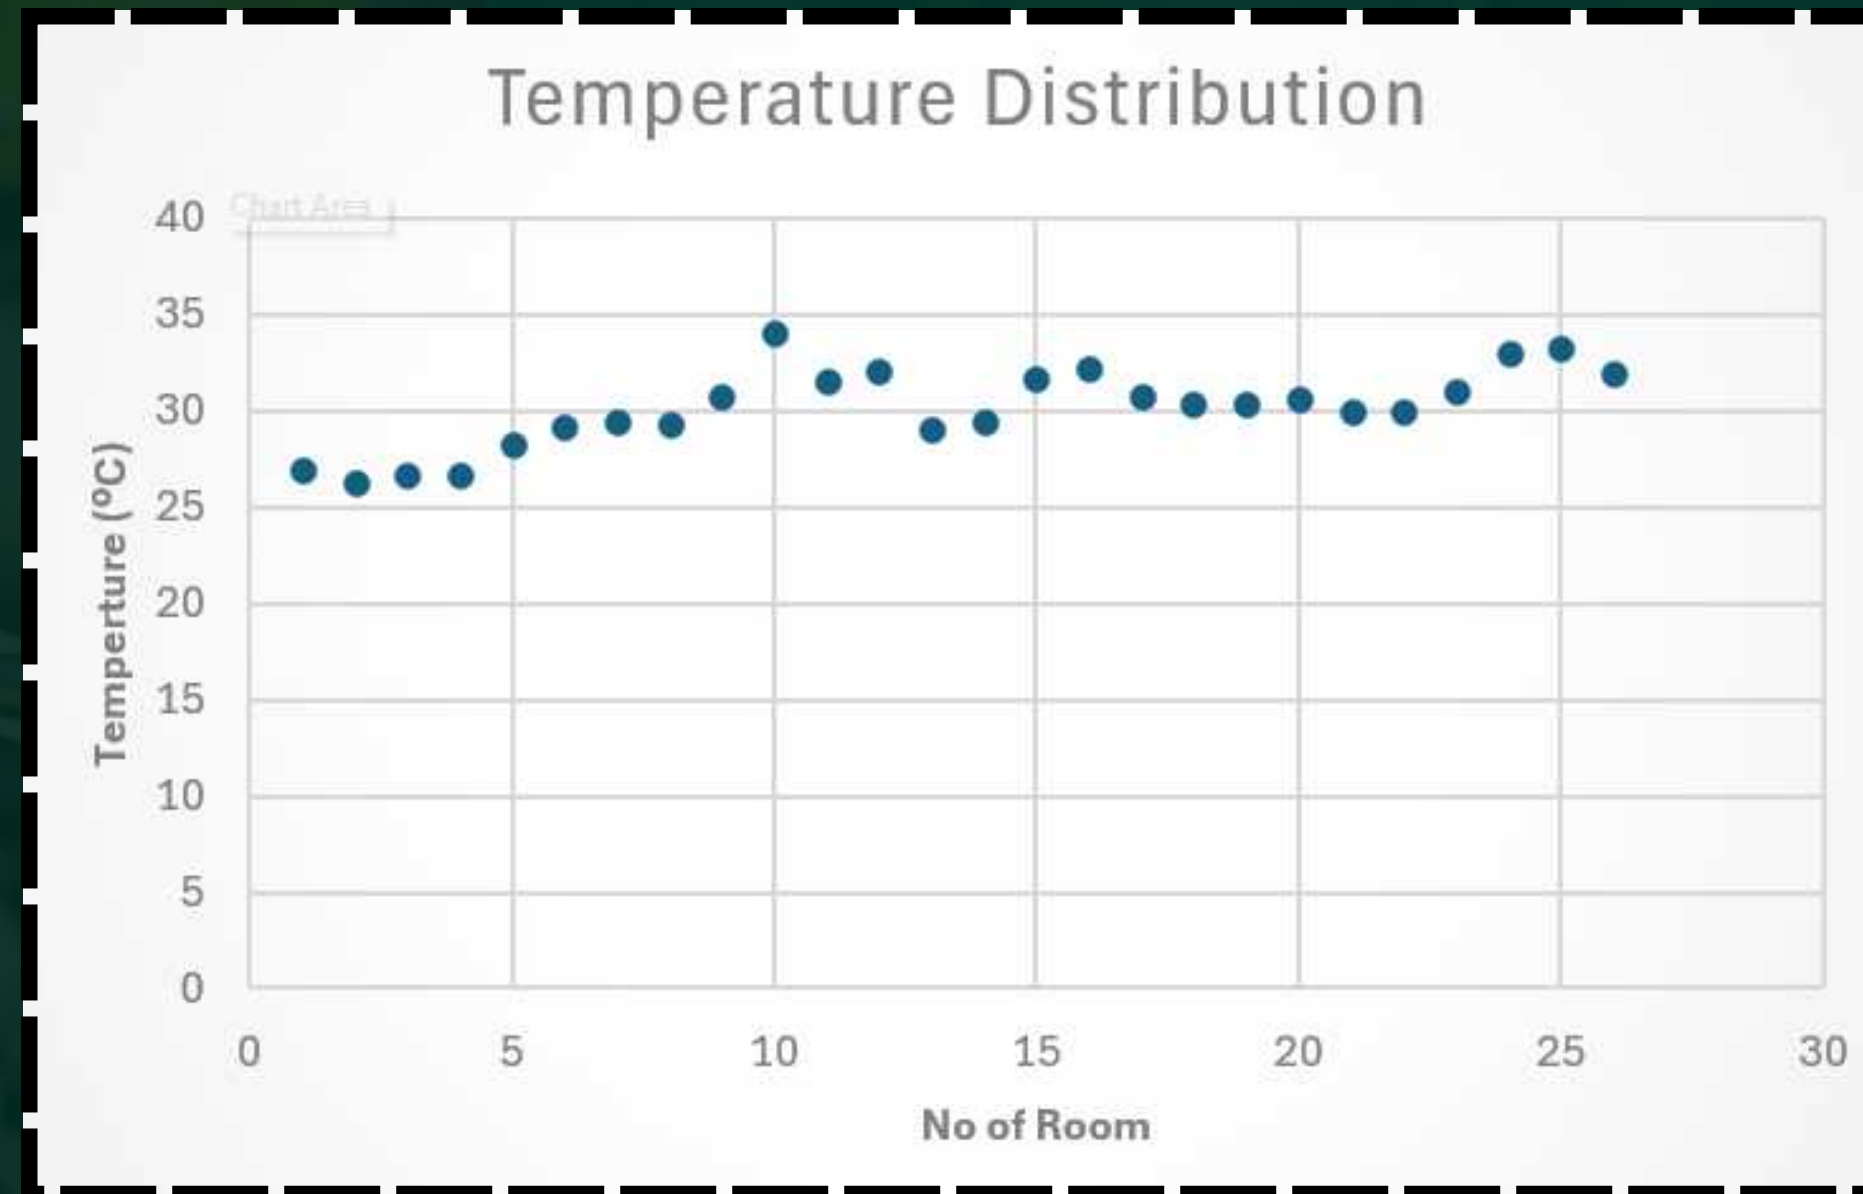
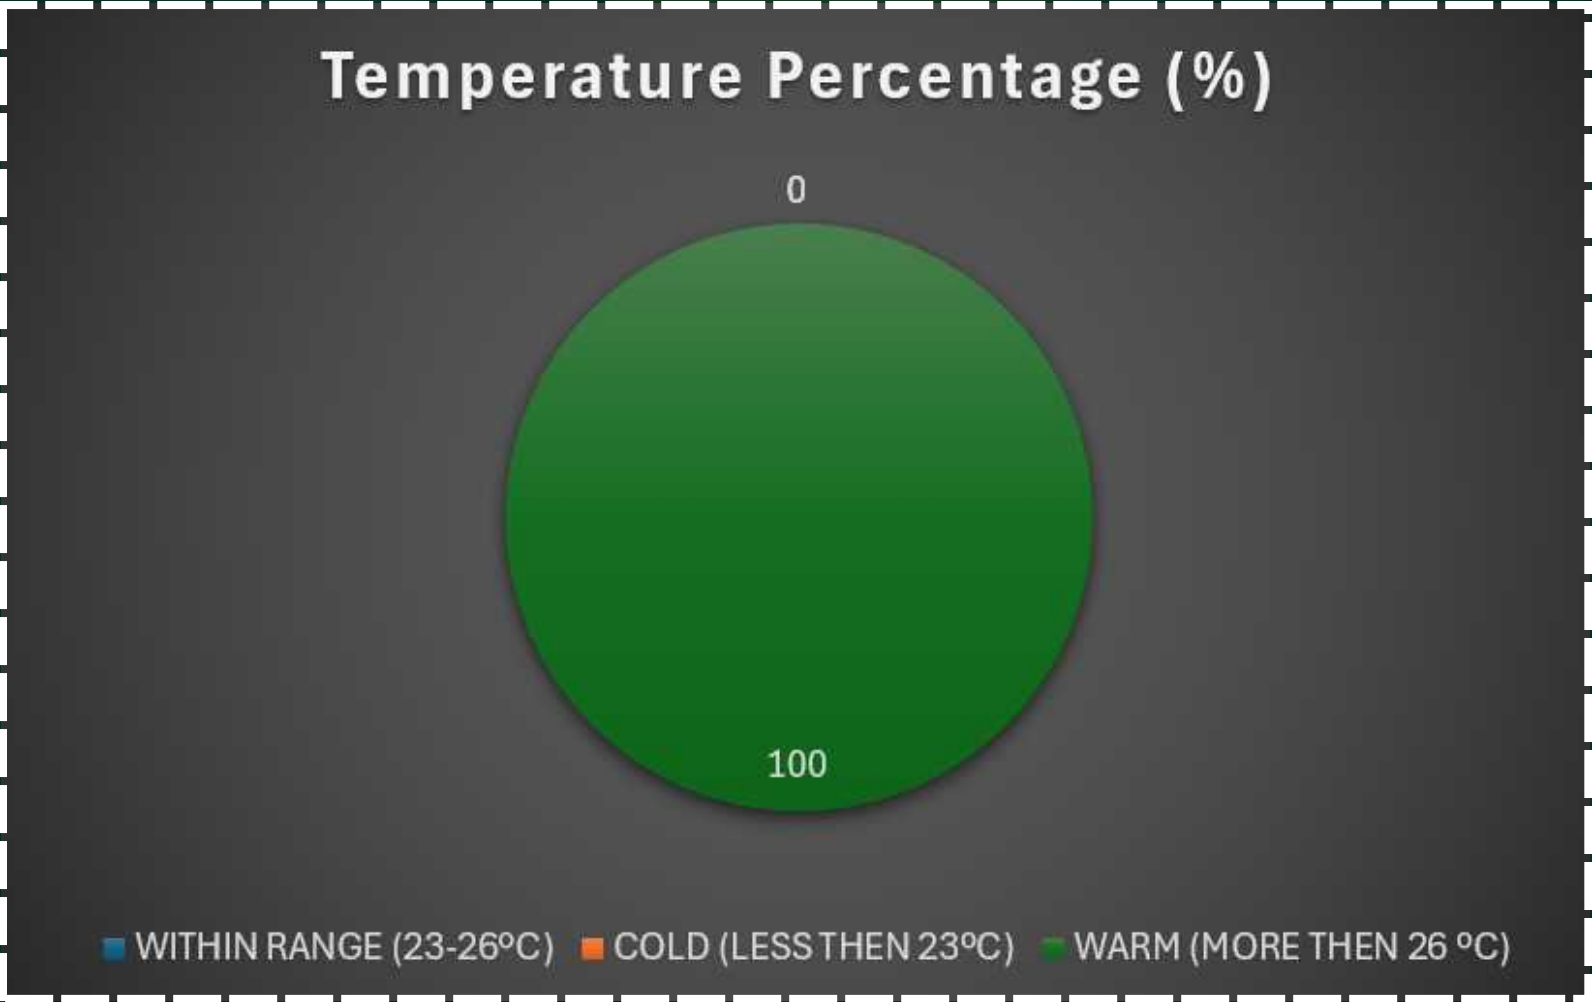
Based on the results, all 26 rooms, which is 100%, were classified as warm because the temperature readings were above 26°C. No room was recorded within the recommended range, and no room was classified as cold. The temperature readings ranged from 26.3°C to 34.1°C, with an average temperature of about 30.2°C.

- 26 rooms were warm
- 0 rooms were within the recommended range
- 0 rooms were cold
- 100% of rooms exceeded the MS 1525 recommended temperature range
- Average temperature: approximately 30.2°C

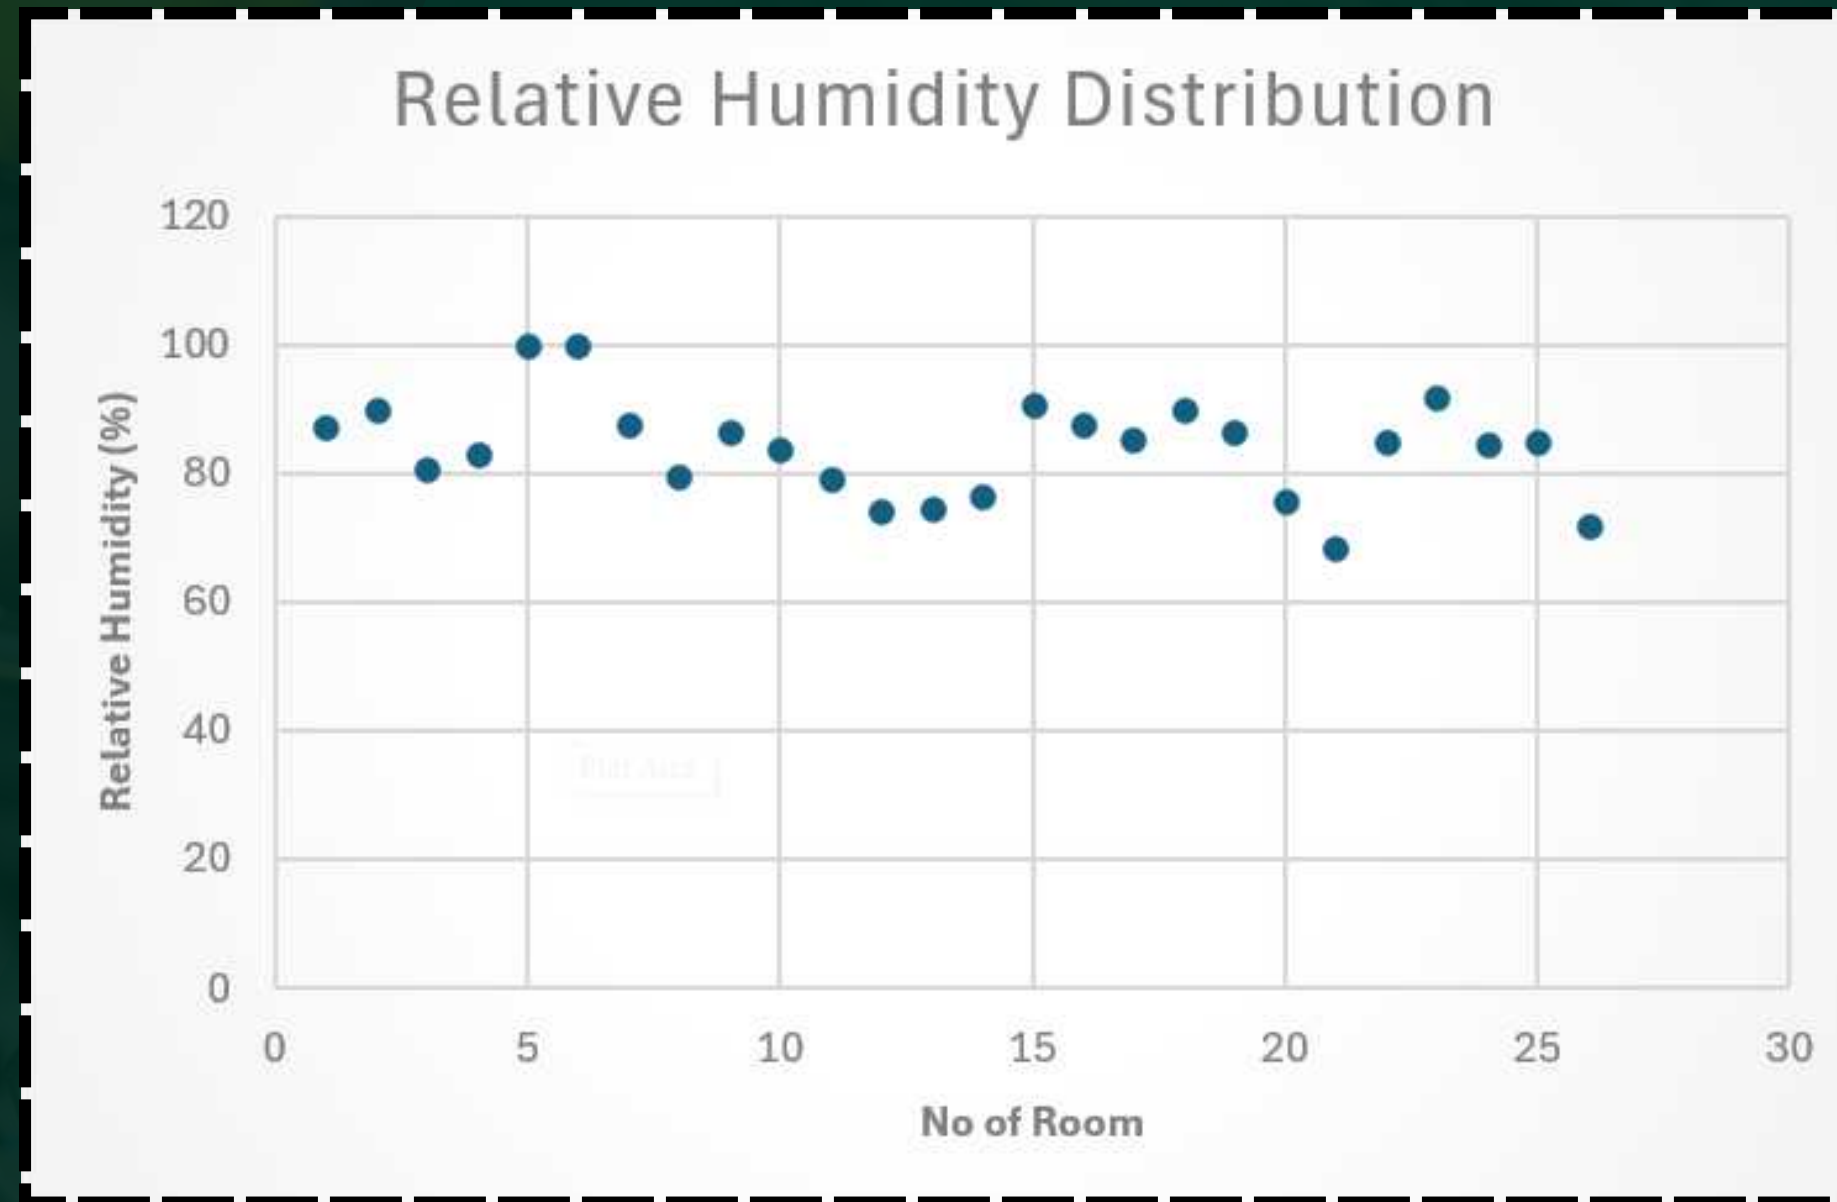
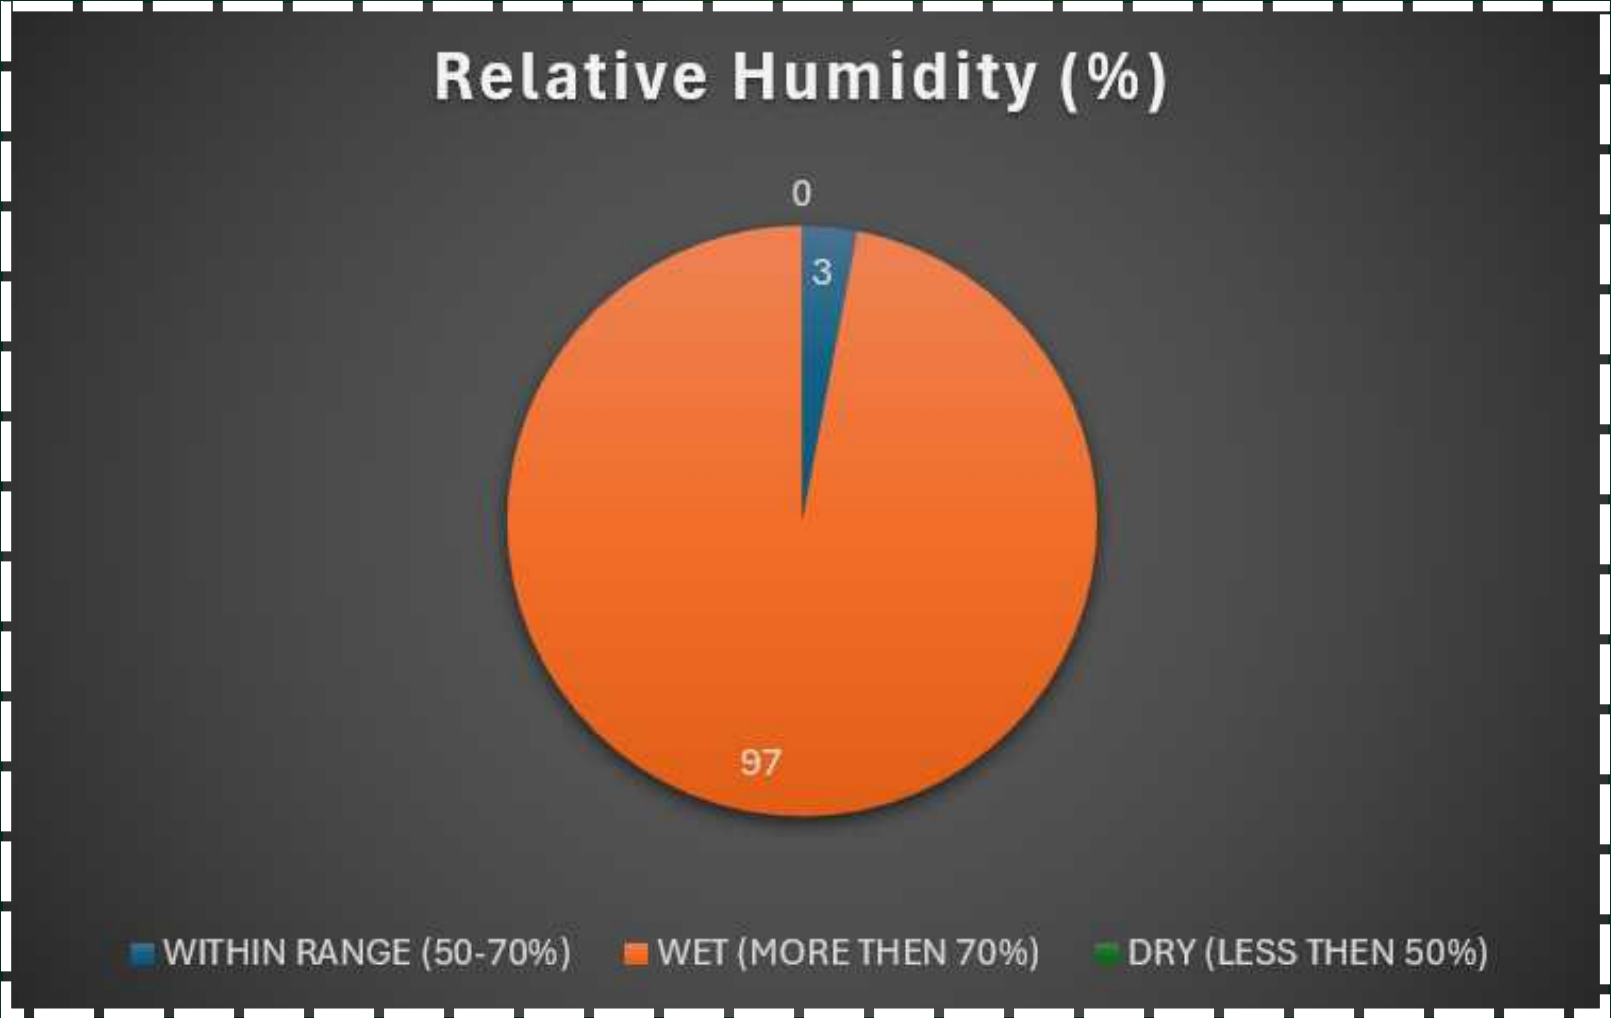
Based on the results, only 1 room, which is 3%, was within the recommended humidity range. Meanwhile, 25 rooms, or 97%, were classified as wet because the relative humidity readings were above 70%. No room was classified as dry. The relative humidity readings ranged from 68.5% to 99.9%, with an average relative humidity of about 84.0%.

- 25 rooms were wet
- 1 room was within the recommended range
- 0 rooms were dry
- 97% of rooms exceeded the MS 1525 recommended relative humidity range
- Average relative humidity: approximately 84.0%

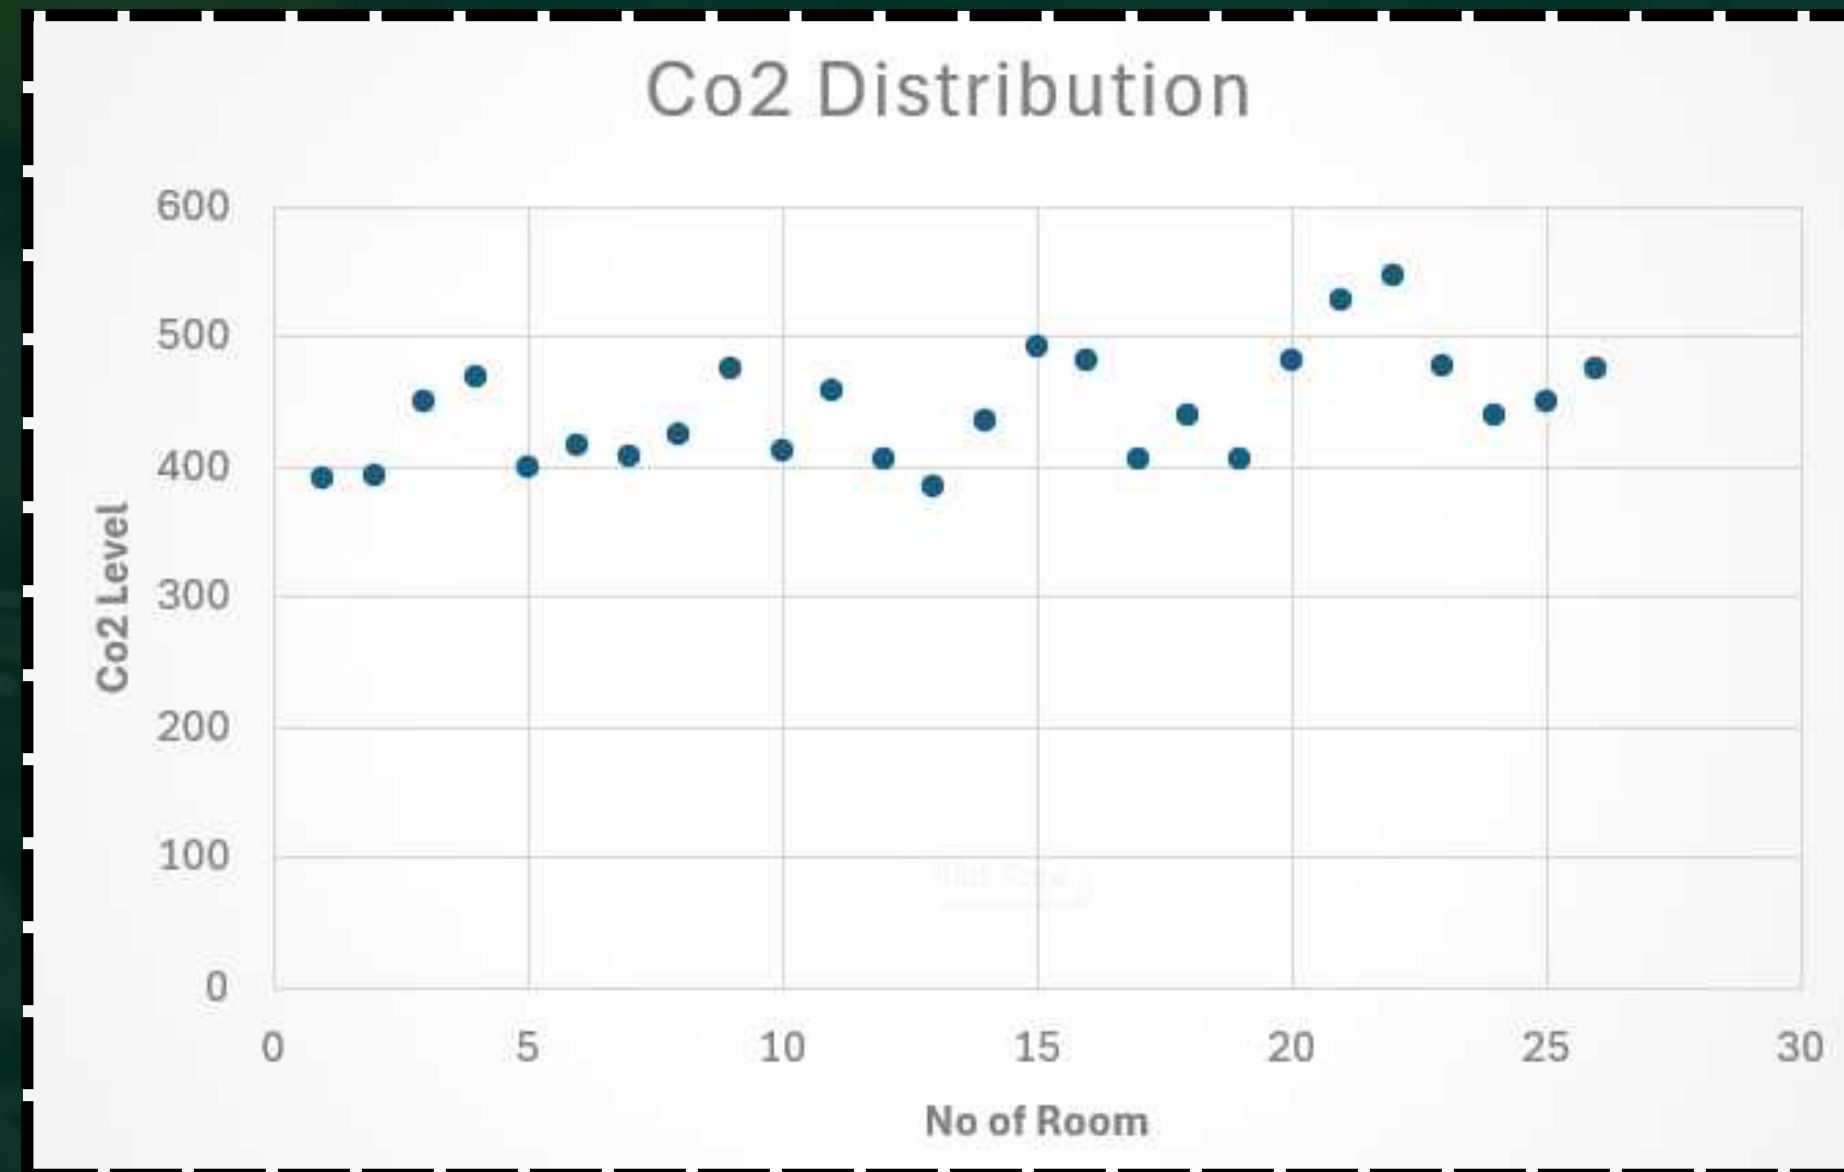
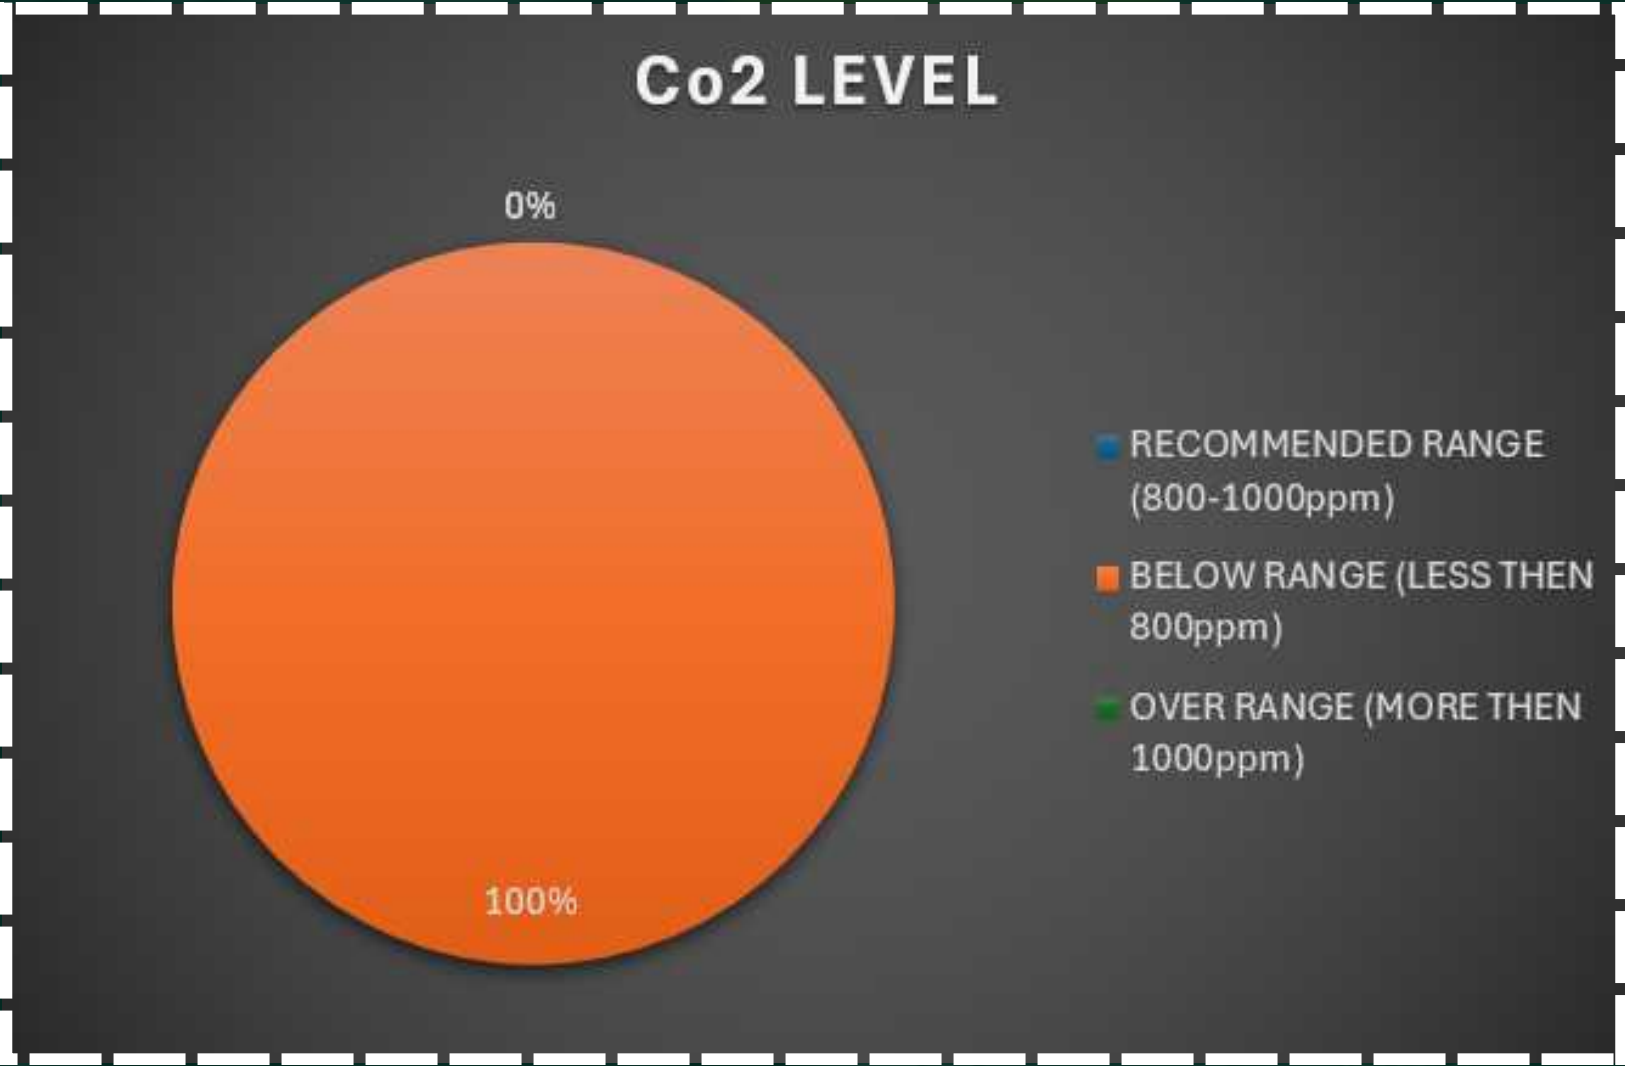
Based on the results, all 26 rooms, which is 100%, were classified as below range because the CO<sub>2</sub> readings were less than 800 ppm. No room was recorded within the recommended range, and no room exceeded 1000 ppm. The CO<sub>2</sub> readings ranged from 385 ppm to 548 ppm, with an average value of about 444 ppm.

- 26 rooms were below the recommended range
- 0 rooms were within the recommended range
- 0 rooms were over the recommended range
- 100% of rooms recorded CO<sub>2</sub> levels below 800 ppm
- Average CO<sub>2</sub> level: approximately 444 ppm
