# PENGURUSAN TENAGA ELEKTRIK

## ROOM DATA SURVEY

The survey covered 26 rooms located within the FTKIP building. Measurements were conducted to evaluate indoor environmental quality and energy consumption characteristics. Parameters measured included illuminance (lux), temperature, relative humidity (RH), and carbon dioxide (CO<sub>2</sub>) concentration. The survey also assessed electrical loads and lighting systems to identify opportunities for energy savings.

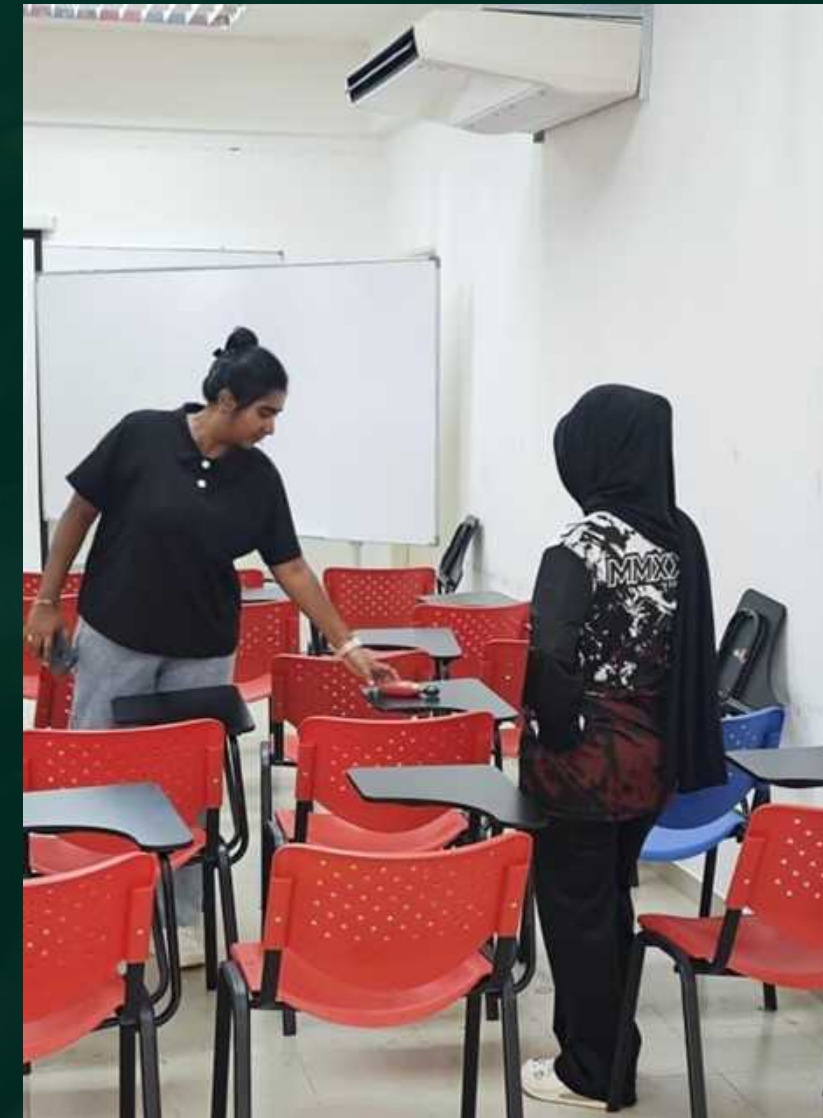
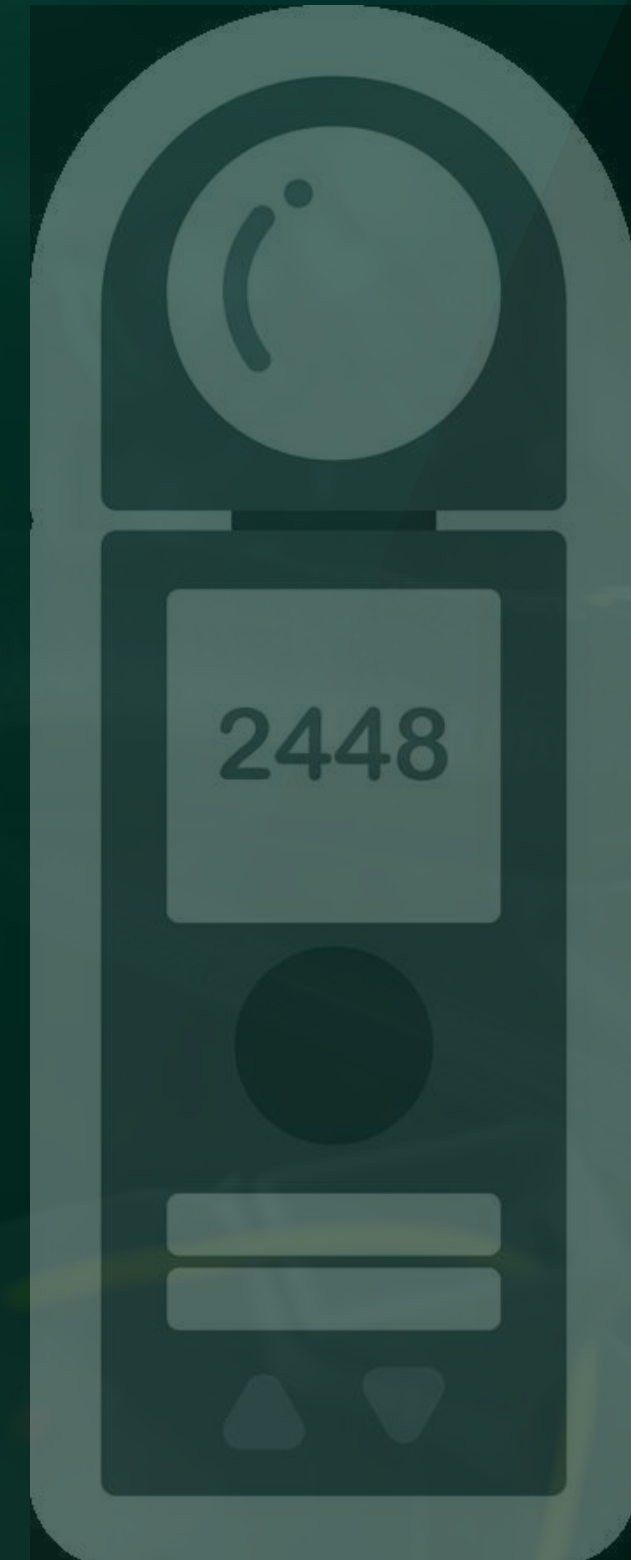
# ROOM ILLUMINATION LEVEL

Illuminance readings were collected from 26 rooms using a Mini Light Meter. Three lux readings were taken for each room and the average value was compared with the MS 1525 recommended illuminance level. A tolerance of  $\pm 20\%$  was used to classify each room as within range, overlit, or underlit.

Based on the results, only 7 rooms, which is 27%, were within the acceptable illumination range. Meanwhile, 17 rooms, or 65%, were found to be overlit. This shows that most rooms had lighting levels higher than the recommended standard. Only 2 rooms, or 8%, were underlit, indicating insufficient lighting.

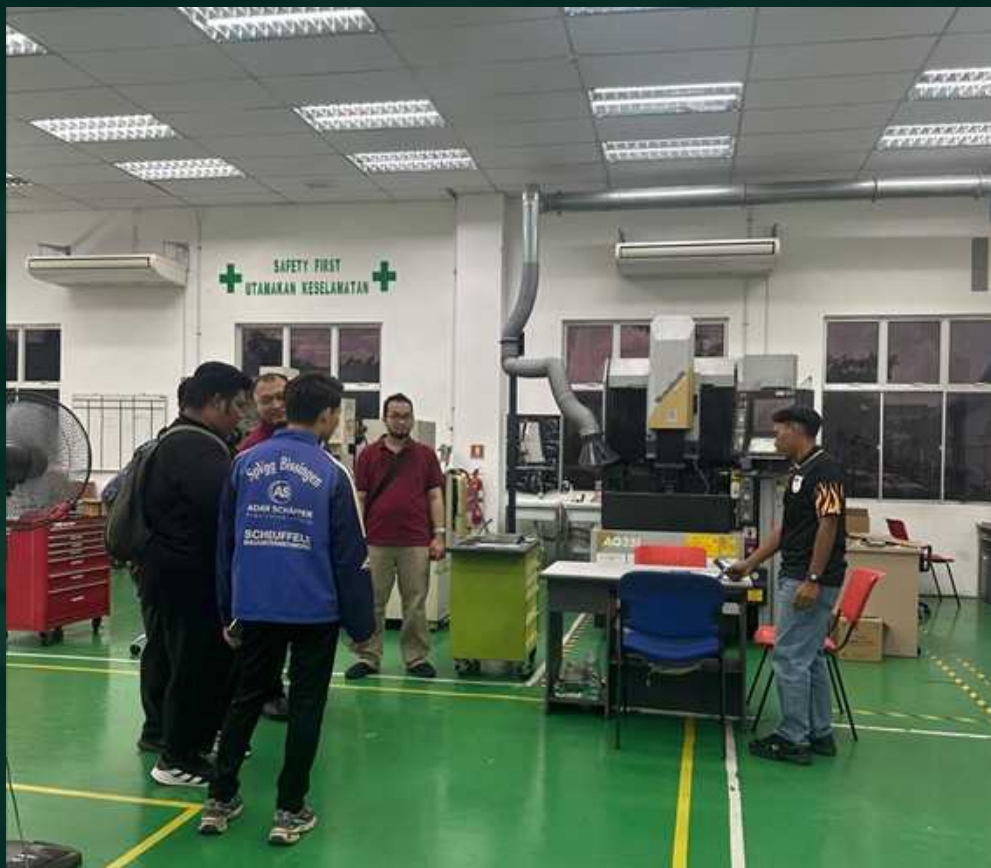
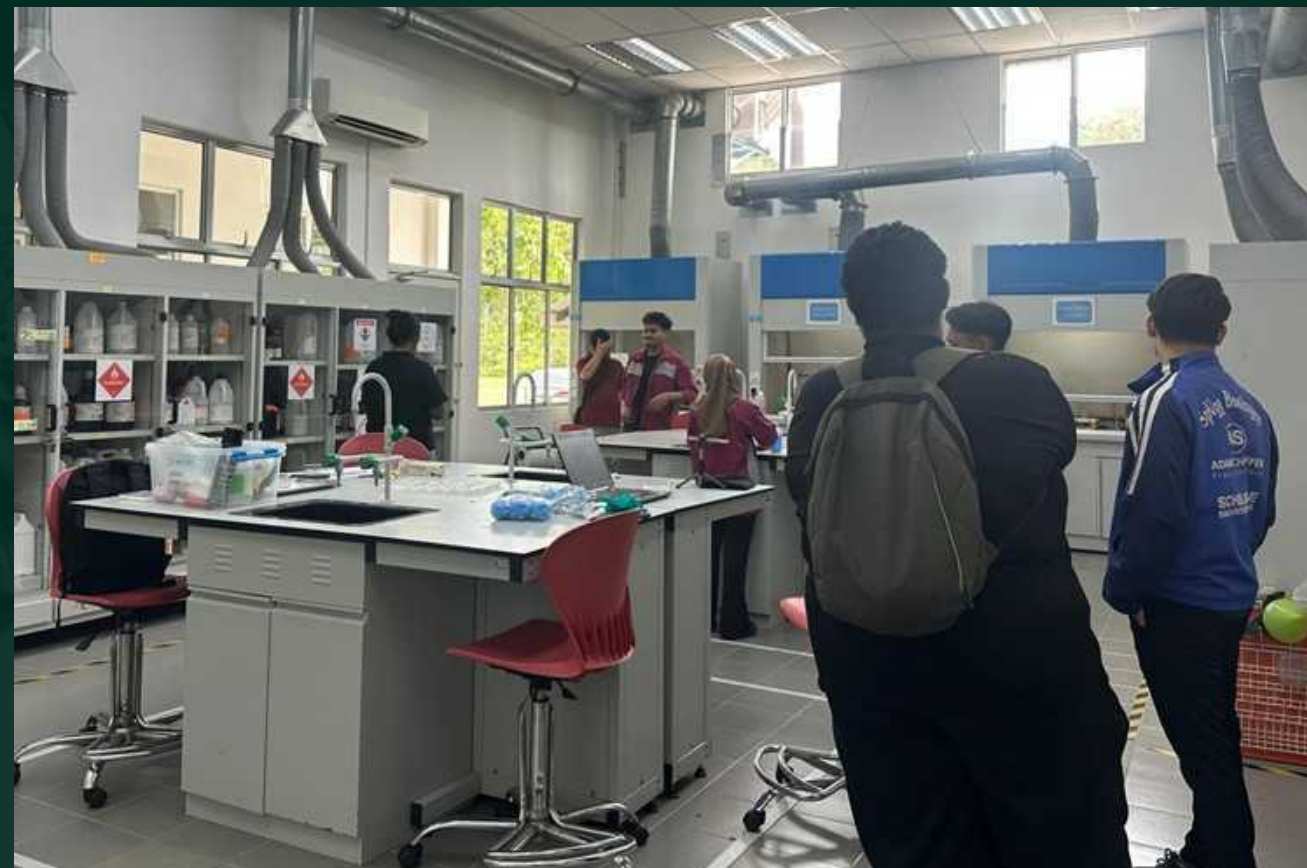
# ROOM TEMPERATURE

Room temperature readings were collected from 26 rooms within the FTKIP building using the KKmoon Multifunctional Air Quality Tester. The readings were compared with the MS 1525 recommended indoor temperature range of 23°C to 26°C. The temperature condition was classified into three categories: within range, cold, and warm.

Based on the results, all 26 rooms, which is 100%, were classified as warm because the temperature readings were above 26°C. No room was recorded within the recommended range, and no room was classified as cold. The temperature readings ranged from 26.3°C to 34.1°C, with an average temperature of about 30.2°C.

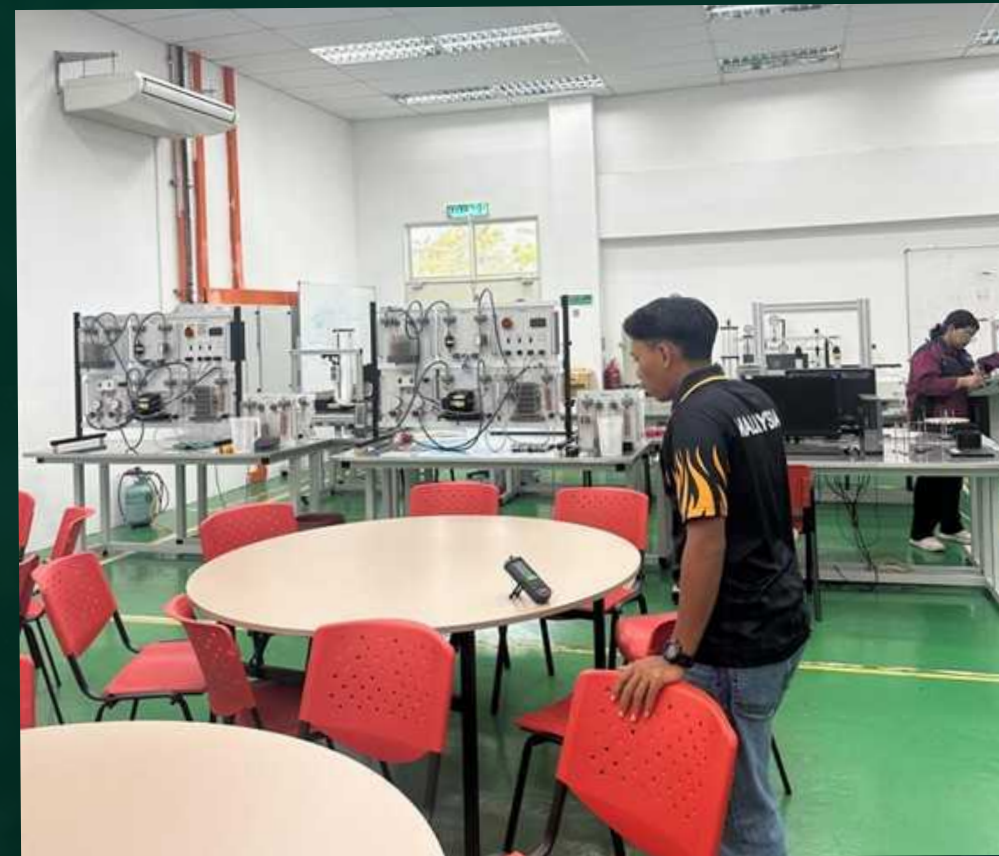
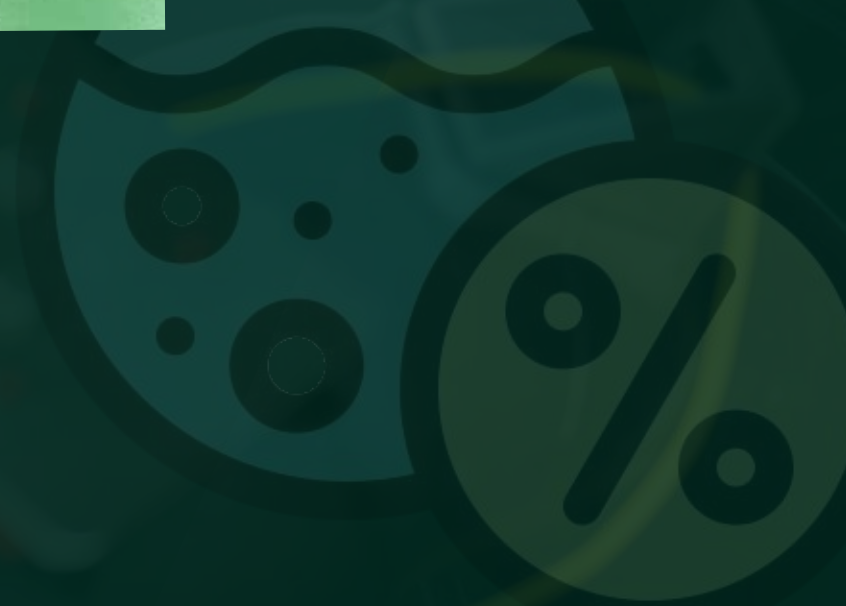
# ROOM RELATIVE HUMIDITY

Relative humidity readings were collected from 26 rooms within the FTKIP building using the KKmoon Multifunctional Air Quality Tester. The readings were compared with the MS 1525 recommended indoor relative humidity range of 50% to 70%. The humidity condition was classified into three categories: within range, wet, and dry.

Based on the results, only 1 room, which is 3%, was within the recommended humidity range. Meanwhile, 25 rooms, or 97%, were classified as wet because the relative humidity readings were above 70%. No room was classified as dry. The relative humidity readings ranged from 68.5% to 99.9%, with an average relative humidity of about 84.0%.
